**GES-DIRTGLUE – PRODUCT TESTIMONIAL: FOR “ MASONPROOF”**

**Our Trial sites;**

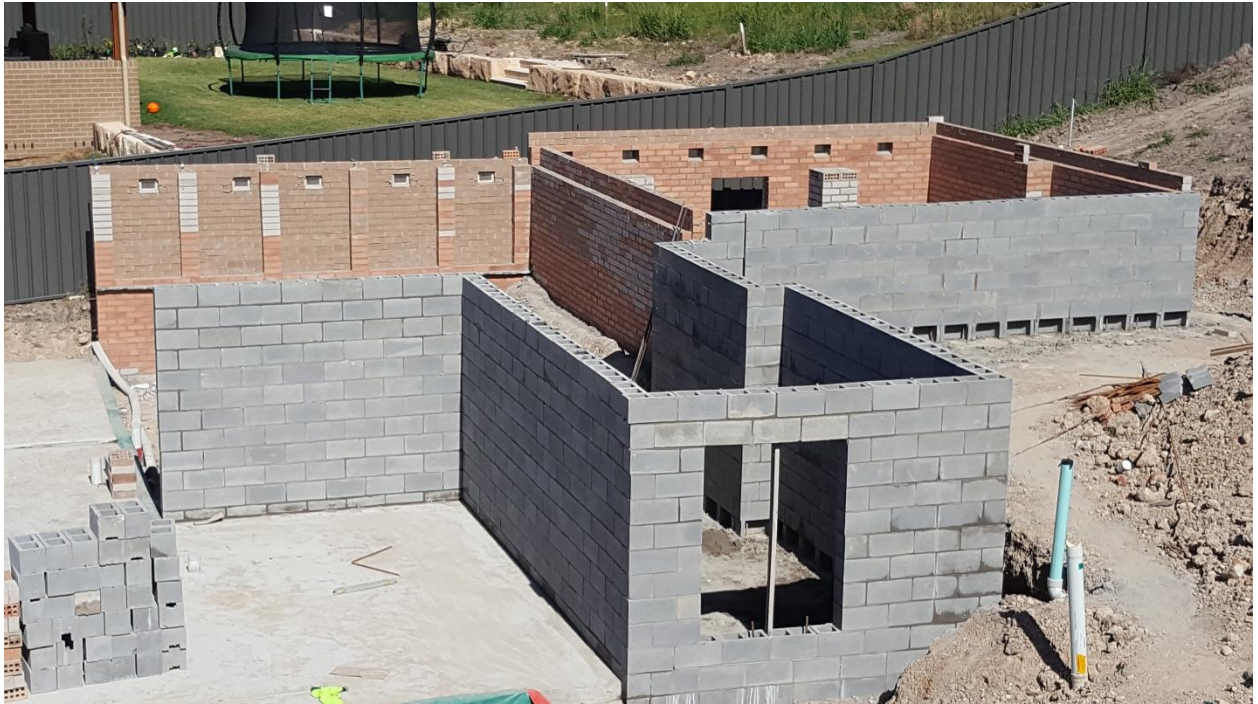
Trial Site 1). 51 Discovery Drive, Fletcher NSW

- Water-Proof the Ground floor Basement Walls
- *Negative Walls (Inside Wall)*
- Positive Walls (Outside Wall facing the Ag-Soil & Water pressure side)

**Before;**

Ges-MasonProof was applied at an application rate of 14 to 1 litre of MP

August/2017; 8 months on, The walls are still dry,  
Further Tests: Feb 2018 in our 2<sup>nd</sup> tests we performed, Again these walls are still dry at the same readings, following a wet 2018 winter season.  
In our mind a positive result for us as a business.

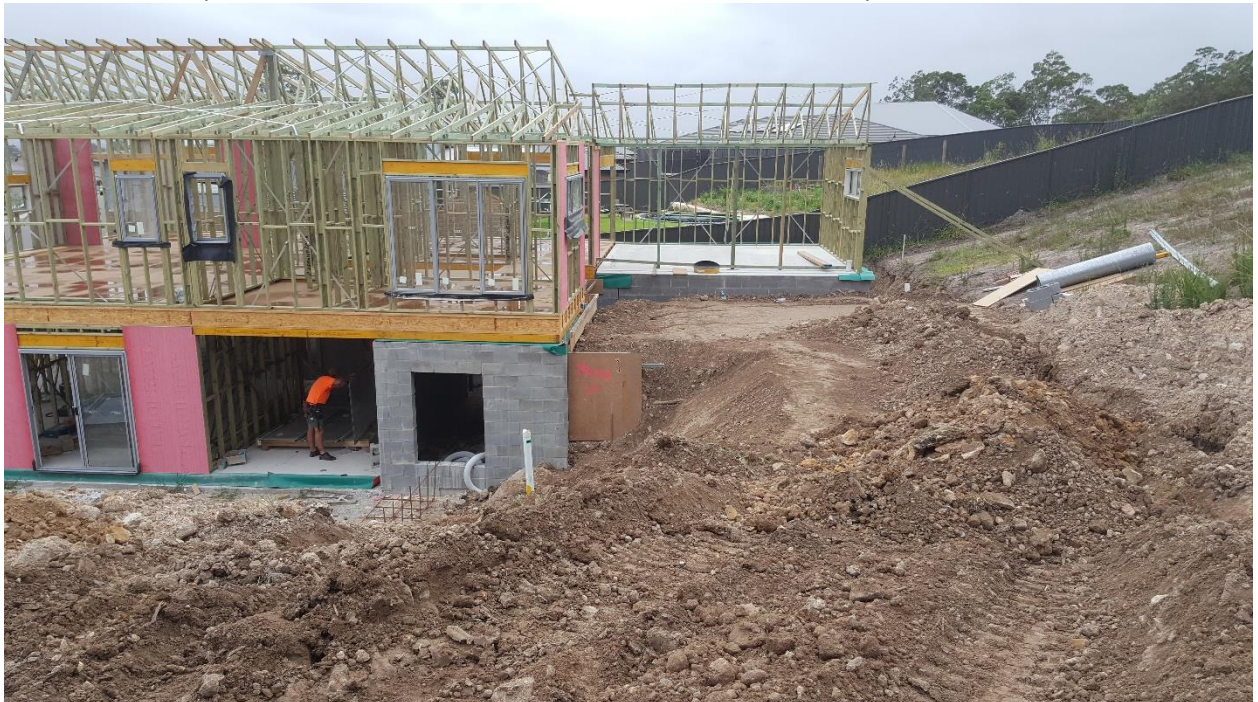
**After,** We Waterproofed with MasonProof, Note the Soil Earth works up to the Outer Walls.

GES MasonProof - Waterproofing application process went ahead in January 2017  
Moisture trial testing was performed in November 2017, showed moisture readings;  
Positive Wall Readings: Tested & showed moisture at between Low 290 to 395 high  
Negative Wall Reading: Tested & showed moisture at between Low 190 to 290 high  
The Minimum Aust-Housing Moisture Reading Standard: Is Fewer than 600

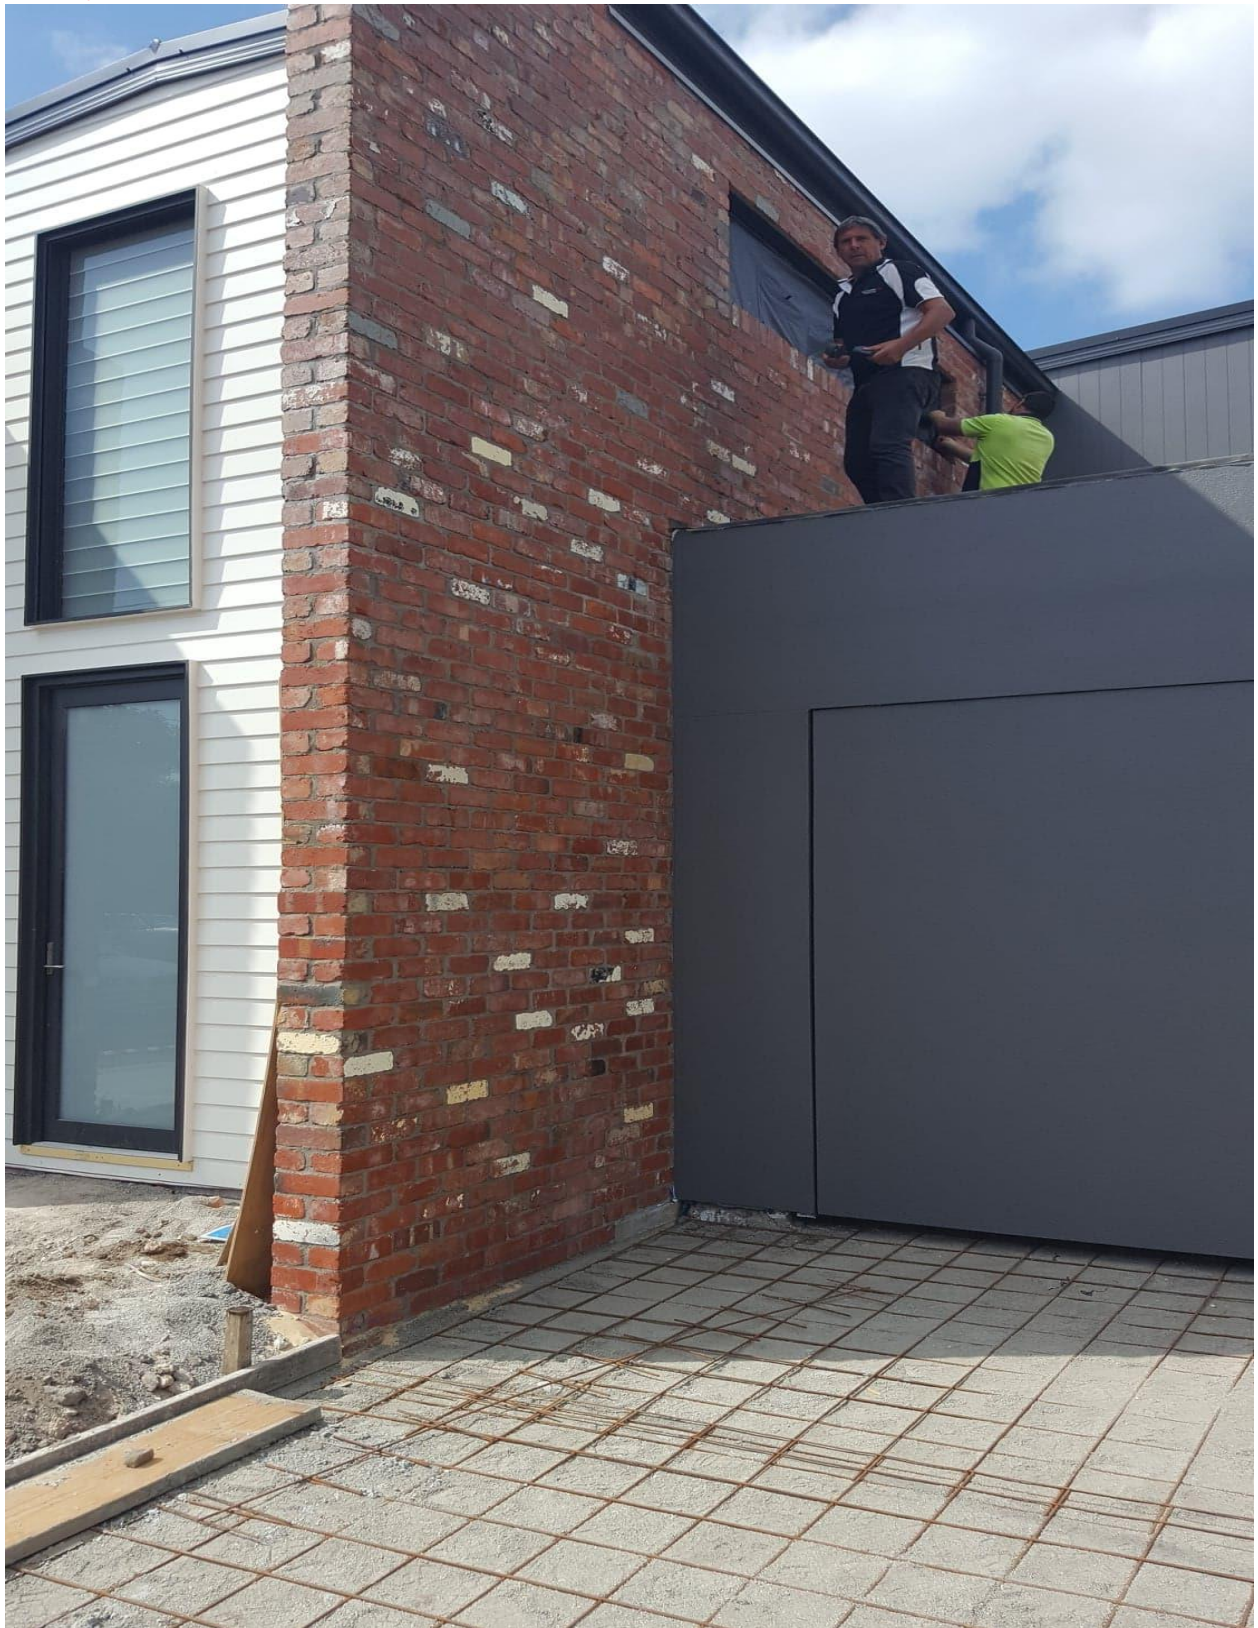
Trial site 2). Elcho Street, Hamilton, Newcastle NSW

- Water Proof Center Brick Divider walls, Between Living Side & Garage,  
Current problem, Water leaking through flashings & Moisture in in the brick wall.

Most of these bricks had defects, cracks and a lot of moisture in them, which added significantly to the problem.

**Before;**

- Step one; GJ Builders sealed all cracks & gaps in the Center line Brick wall.
- GES-Dirtglue Applicators; Used MasonProof to water proof the Masonary Bricks  
MasonProof Application Mix ratio 14 to 1.
- Application Date: 3<sup>rd</sup> April 2018
- Inspection Date: 4<sup>th</sup> April 2018  
Which included a Water Splash test onto the exterior outside walls and Internal walls.

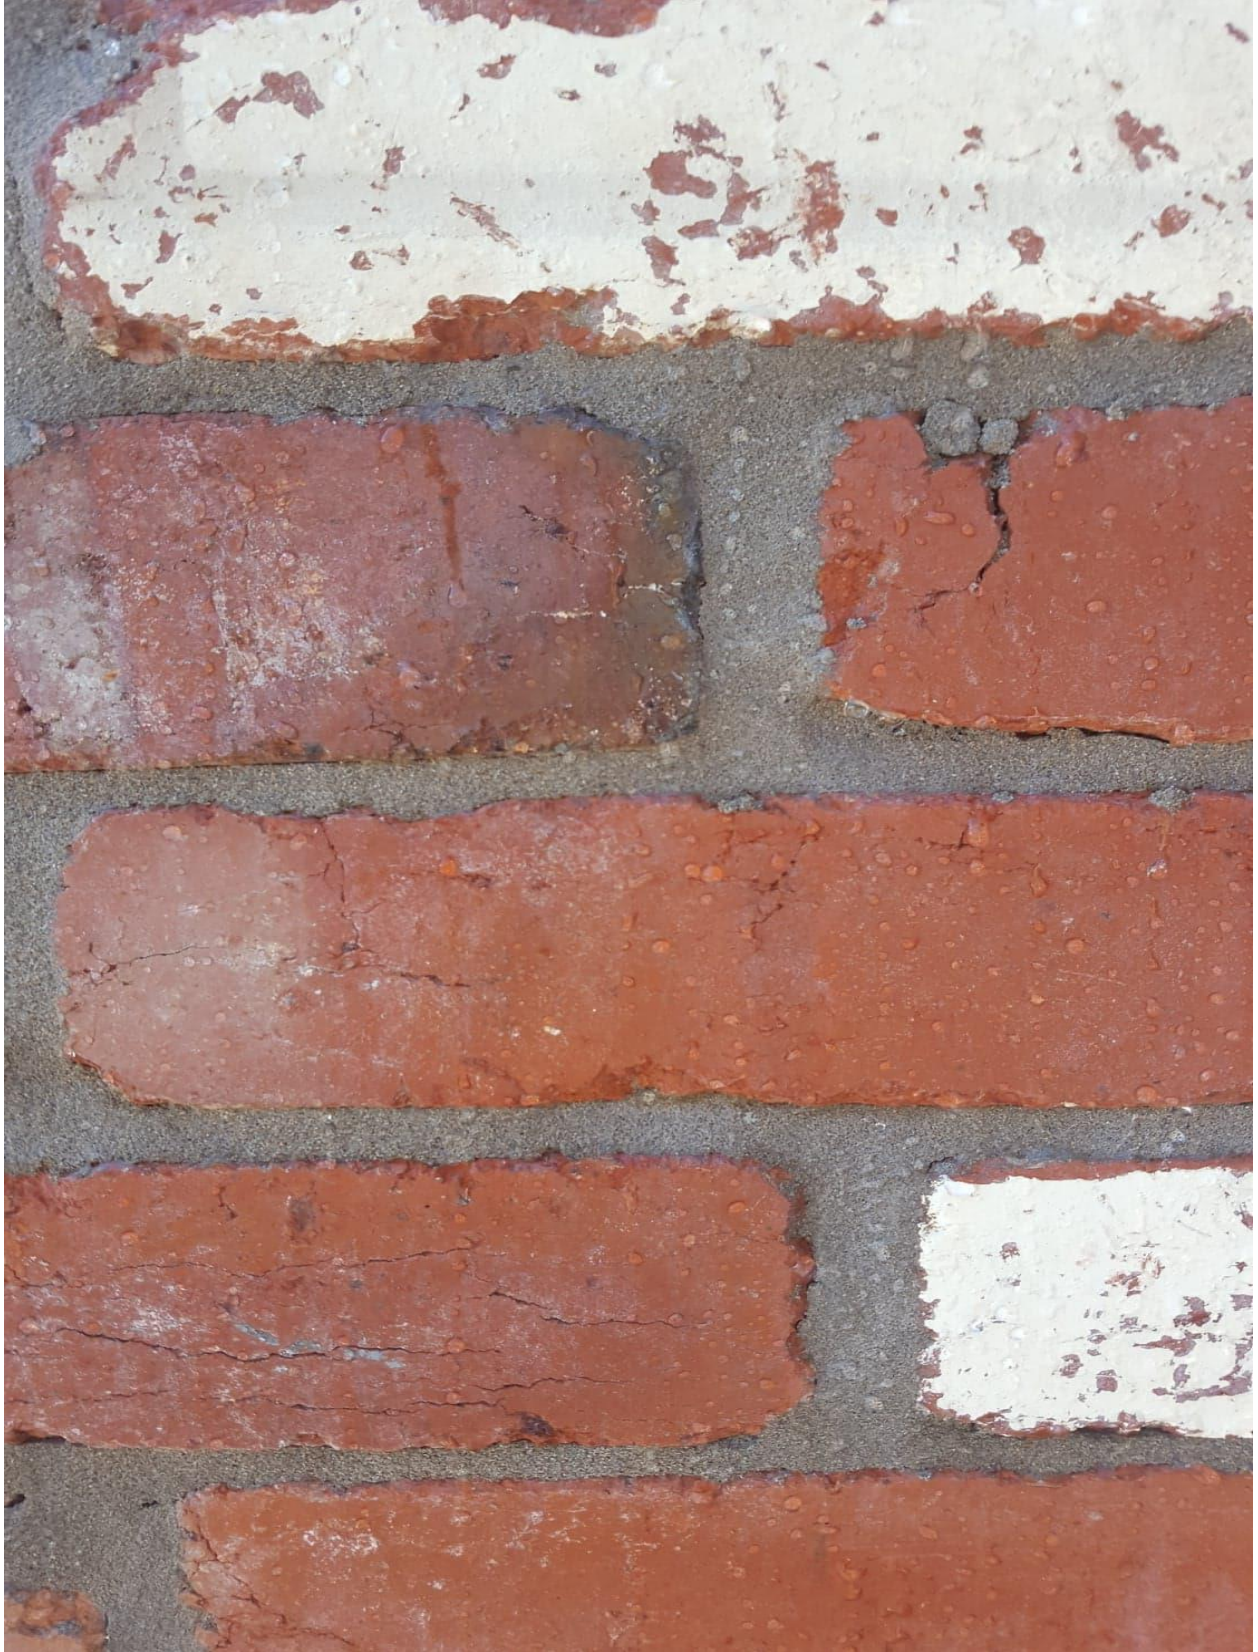
After; MasonProof is applied, Check the Water beads to show it working.

- An on site inspection & Appraisal process
- Solutions and advice to solve the Water Dampness issues
- Picking the right product: MasonProof
- And working through how to fix and apply MP to the site.
- Overall the Home is still water tight, No signs of dampness.
- We have a very happy customer.
- We are very grateful for the support and professional service provided to us by GES-Dirtglue.
